## Project Profile

# Residential Deck Project

- ◆ St. Simons Island, GA
- ◆ Various substrates recovered
- ◆ Multiple deck levels

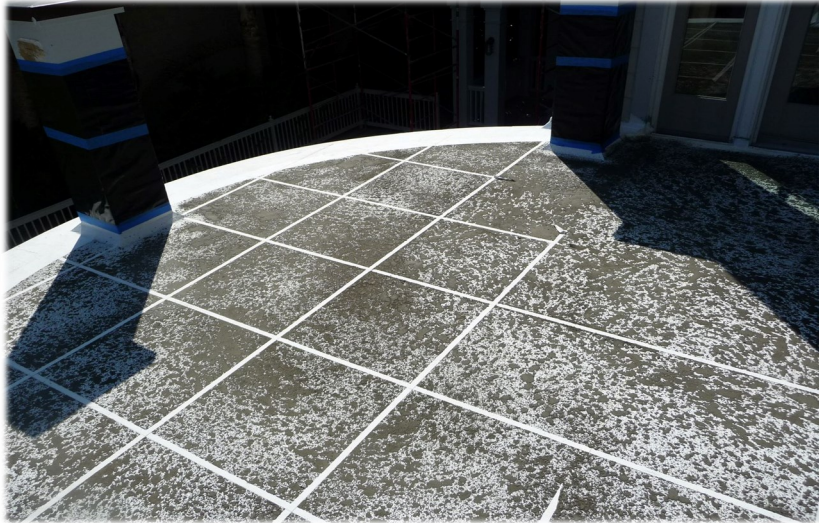
After the Acrylabs Base System was installed, painter tape was used to stimulate grout lines, Acrycrete slurry was applied with splatter technique, and painter tape was removed creating clean grout lines

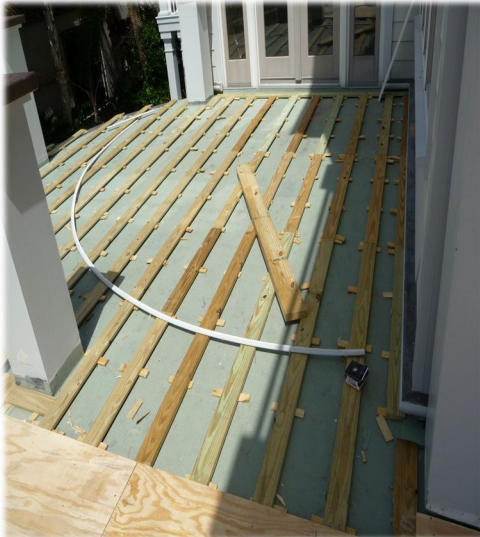
Installing new deck system over old deck

This project was completed by a more experienced crew working with Acrylabs Acrycrete and DEK-coat. The damaged deck was recovered with lath board and 3/4" T & G plywood. Seams were stripped with 4" fabric then the Base System was installed.

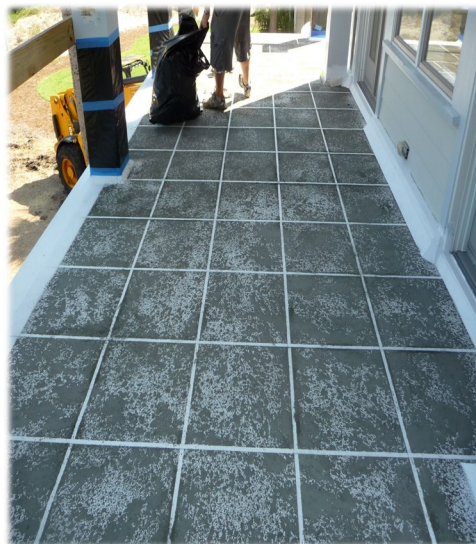
Acrycrete splatter technique knocked down with bull float

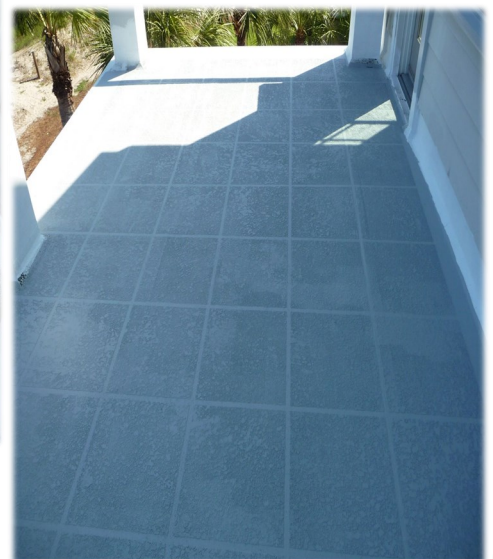
Two coats of Acrylabs DEK-coat finish applied
